**Flood Control Project Maintenance
Levee Inspections**

Fall 2011 Levee Maintenance Deficiency Summary Report

Reclamation District No. 0755 Randall

Levee Inspection Report By Mile - Fall 2011

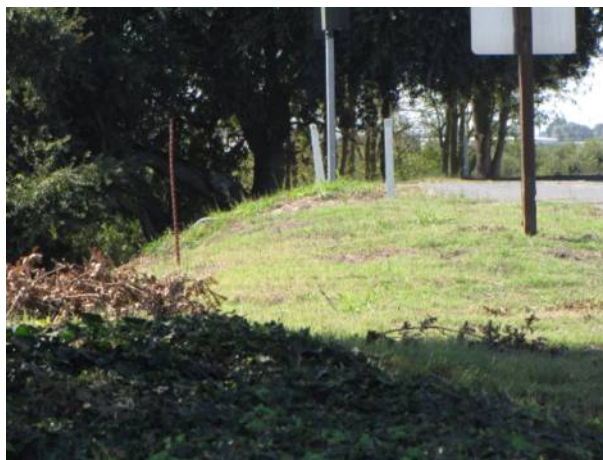
Levee Mile Report Line	1
Start Levee Mile	0.00
End Levee Mile	0.00
Location	Land Side
Category	Earthen Levee
Item	Vegetation

LMR No.	Levee Mile		Category	Item	Location *	Rating **	Action/Comment	GPS Latitude/Longitude		Issue No. Photo
	Start	End						Start	End	
1	0.00	0.00	Earthen Levee	Vegetation	LS	M	Remove the wild growth other than native grasses from the levee slopes. Inspector Comments: District in process of mowing levee slopes during this inspection.	° °	° °	1 Y
2	0.02	0.02	Earthen Levee	Encroachments	LS	PO	Fences Inspector Comments: The land owner has installed the fence without a permit, I met with owner 10-16-2009. An application is being prepared for submittal to date. Photos were taken.	38.347517 ° 121.535943 °	38.347517 ° -121.535943 °	23 Y
3	0.14	0.14	Earthen Levee	Vegetation	WS	A	Remove the wild growth other than native grasses from the levee slopes.	38.346964 ° -121.537993 °	38.346964 ° -121.537993 °	2 Y
4	0.55	1.78	Earthen Levee	Animal Control	LS	M	Exterminate rodents and backfill and compact or grout burrows.	38.345637 ° -121.545270 °	38.337432 ° -121.564027 °	4

Standing on the landside slope of levee mile 0.14 looking downstream. Photo taken 10-06,-2011.

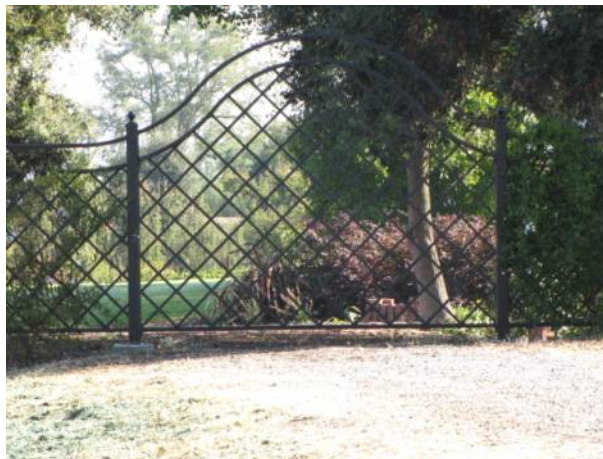
Levee Mile Report Line	2
Start Levee Mile	0.02
End Levee Mile	0.02
Location	Land Side
Category	Earthen Levee
Item	Encroachments

This is the gate Mr. Hemley has installed without a permit.

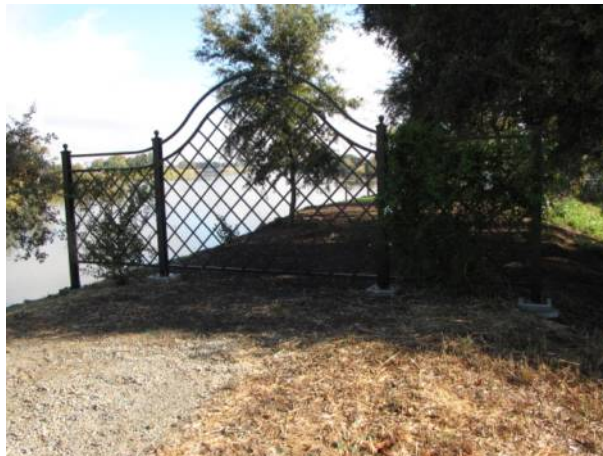
Levee Mile Report Line	2
Start Levee Mile	0.02
End Levee Mile	0.02
Location	Land Side
Category	Earthen Levee
Item	Encroachments

Hemley's gate

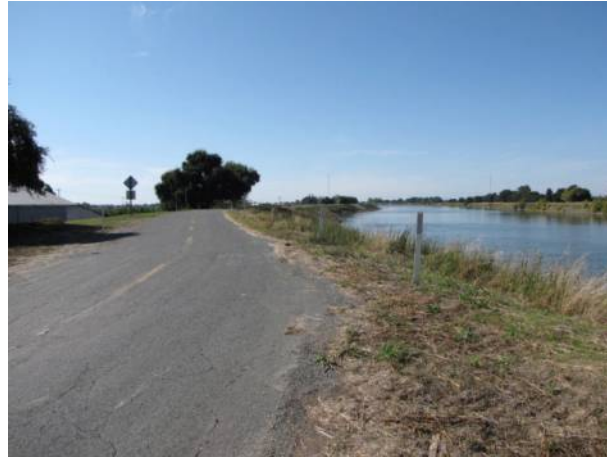
Levee Mile Report Line	3
Start Levee Mile	0.14
End Levee Mile	0.14
Location	Water Side
Category	Earthen Levee
Item	Vegetation

Standing on waterward shoulder of RD 755 Levee mile 0.14 looking downstream. Photo taken 10-06-2011.

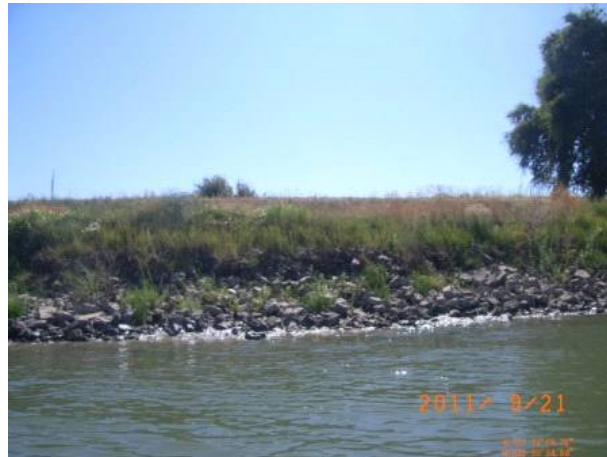
Levee Mile Report Line	6
Start Levee Mile	1.21
End Levee Mile	1.30
Location	Water Side
Category	Supplemental
Item	USACE Erosion Survey

5	0.79	0.83	Earthen Levee	Animal Control	LS	C	No rodents visible, but rodent burrows visible; need to backfill and compact or grout burrows.	38.344608 ° -121.549855 °	38.344403 ° -121.550523 °	5
6	1.21	1.30	Supplemental	USACE Erosion Survey	WS	M	Inspector Comments: 2003 - Toe and lower slope eroding, rock in water and a few pieces on the slope; rock at upstream and downstream ends. 2005 - Looks a little worse. Two major holes with vertical banks and smaller intermittent pockets in between. Stone is present upstream, downstream, and at toe. 2008 - Repaired at both ends (50 ft of new stone) but middle remains unrepaired. 2011: Site extended downstream to include new scour. [2011 Site ID: SAC_35-4_L]	38.343071 ° -121.557706 °	38.342426 ° -121.559163 °	3 Y
7	1.74	1.83	Earthen Levee	Encroachments	LS	PO	Landscaping	38.337702 ° -121.563618 °	38.336855 ° -121.564545 °	13

USACE 2011 Photo #1

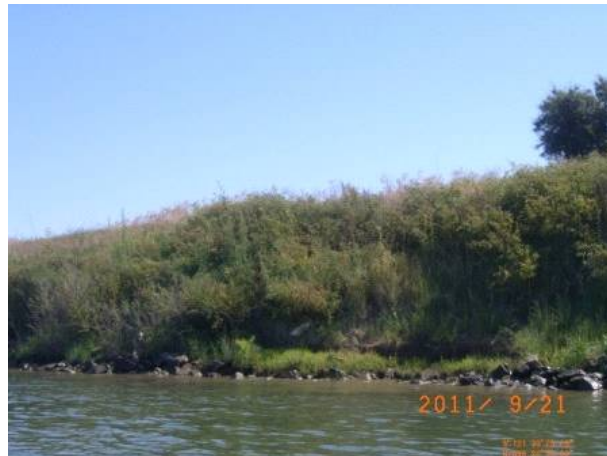
Levee Mile Report Line	6
Start Levee Mile	1.21
End Levee Mile	1.30
Location	Water Side
Category	Supplemental
Item	USACE Erosion Survey

USACE 2011 Photo #2
